Analysis Experimental and Numerical of Pounding Between Two Adjacent Structures with Unequal Highs

^{1,2} Department of Civil Engineering, College of Engineering, University of Diyala, Diyala, Iraq, 32001

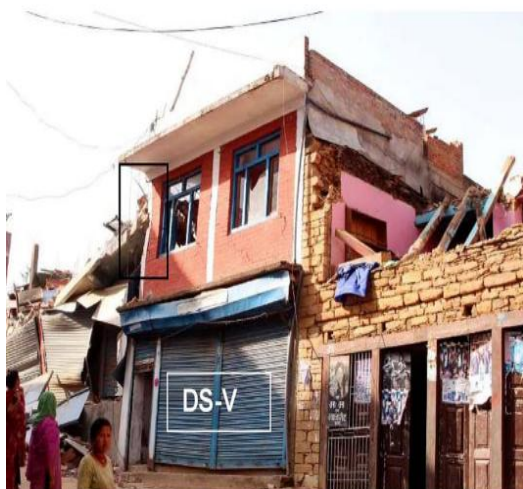
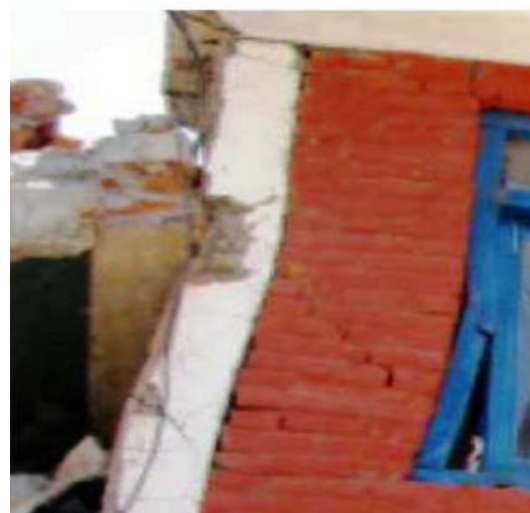
(A) Impact from a collapsing building

(B) Damage detail

Fig. 1 The damage caused by the collision of the collapsed adjacent structure [12].

A typical example of a collapsing building colliding with an adjacent building is depicted in Fig. 1. As can be seen, the floor diaphragm of the collapsed building struck the nearby RC structure during the second-story column, causing damage to the building that was comparable to mid-column pounding. The damage caused by the collision of the collapsed adjacent structure could not have been avoided, not even with a considerable gap between the buildings [12].

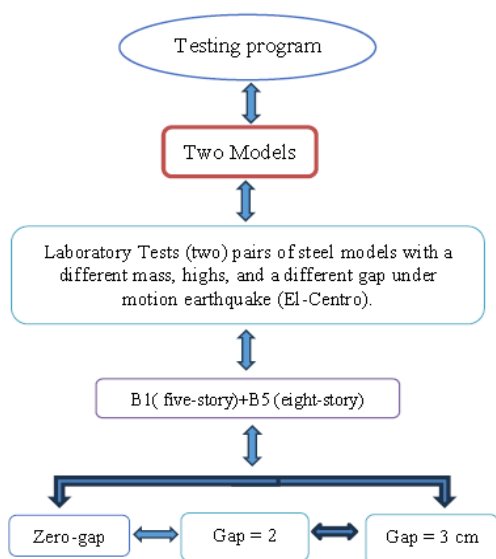
Fig. 2 The Flow chart of experimental work.

Scale-down 1/15 five-story and eight-story steel replicas were built specifically for the experiment and utilized as test subjects, as shown in Fig. 2, at two different heights of 1500 and 2400 mm. They were all built with four floors per story, each measuring 300 mm by 300 mm overall and having a 1 mm thickness, connecting bolts for the beams and columns. The columns were placed 300 mm apart in a rectangular configuration around the shaking table. Each story rises 300 mm, and the beam column has a square cross section (20 x 20) mm with a length of 300 mm. Ceramic tiles measuring 300 by 300 mm were attached to the steel of each floor, with a thickness of 12 mm, to replicate the mass of the models. And was used weight $W=5\text{kg}$ a thickness $t=10\text{ mm}$, with a dimension of 265 x 265 mm. as shown in Fig. 3.

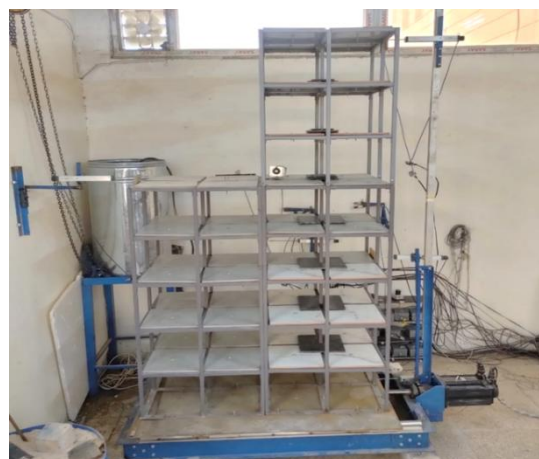
Fig. 3 Two steel models, five-story and eight-story, on a shaking table at zero-gap.

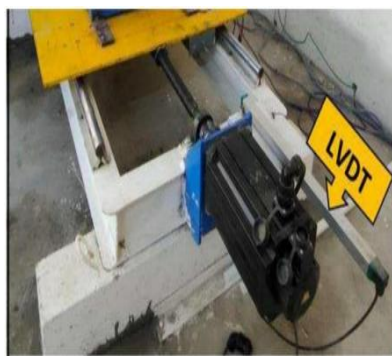
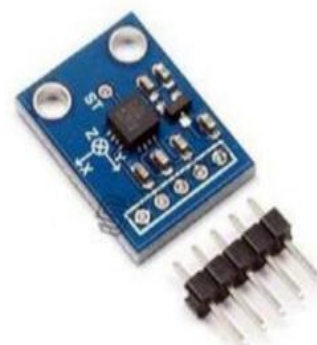
(A) The displacement sensors (LVDT) (with a range of 500 mm).

(B) accelerometer sensors.

Fig. 5 The displacement sensors and accelerometer sensors.

Following the experimental models' placement on the shaking table at zero gaps, the displacement transducer (LVDT) and the accelerometer sensors (GY-61W) are displayed in Fig. 4. The five-story and eight-story adjacent steel models have varying highs and gaps (0-2-3) cm. The sensors were placed in the manner shown in Fig.3; On the third and eighth, of the right and left models, type a) accelerometers GY61W and a linear variation displacement transducer (LVDT) with a 220 mm variety were mounted. On the base of the shaking table depicted in Fig. 5 (a, b), one type of GY-61W accelerometer and one LVDT with a 500 mm variety were mounted.

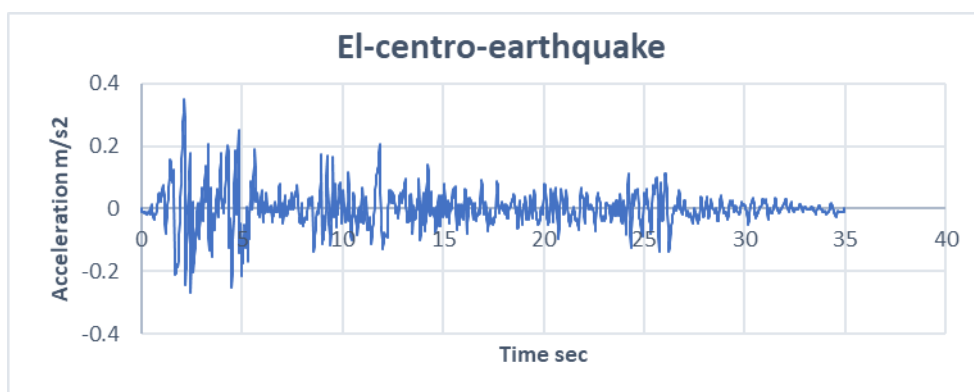
Fig. 6 Time history of earthquakes

Under the El-Centro earthquake of 1945, shaking table tests were conducted using earthquake ground motions Fig. 6. The model is then set up for inspection by being placed on the vibration table. Next, the sensor device that gathers and stores the data from the inspection is turned on, and the earthquake ground data is uploaded to the device program. Subsequently, the device program receives an operating command, which transforms the tremor data into commands. The table moves

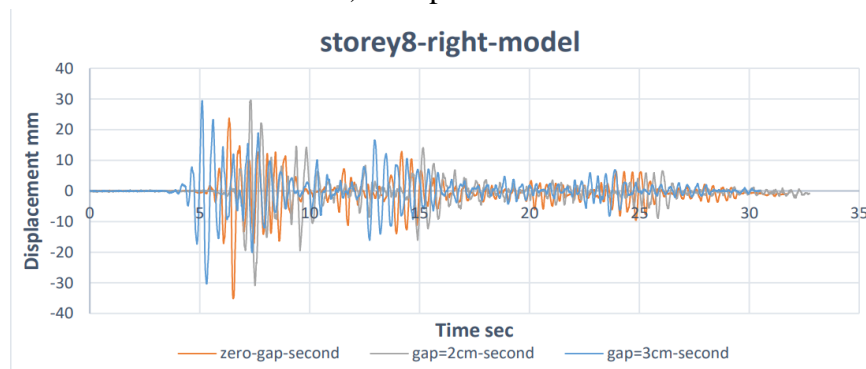
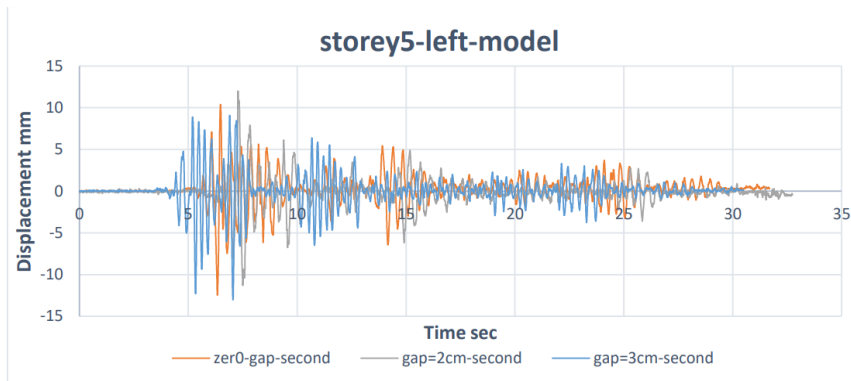
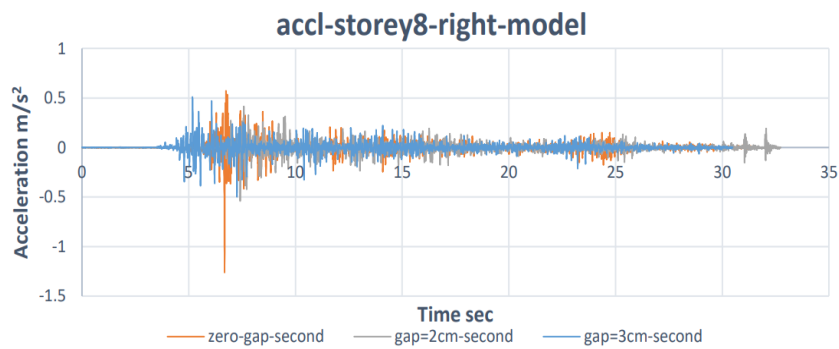
a) Displacement

b) Displacement

c) Displacement

d) Acceleration

e) Acceleration

Fig. 8 The displacement and acceleration at story three, story eight-right (B5) model, and at story five-left(B1) model, under El-Centro earthquake.

This section shows the results achieved from the laboratory work and finite element model by using (ABAQUS) software. As shown in Fig. 8, the displacement and acceleration that were attained by shaking table, and in Fig. 9, the displacement and acceleration that were attained from the finite element model in (ABAQUS) software, for different gaps under the ground motion excitation utilized, are El-Centro 1945.

- 1- In the experiment, the peak displacement at story three was reduced by 10%.
- 2- Theoretically, the peak displacement at story three was reduced by 13%, and acceleration at story three was reduced by 5%.

- 3- In the experiment, the peak displacement at story eight was reduced by 9%, and the acceleration at story eight right model was reduced by 48%.
- 4- Theoretically, the peak displacement at story eight was reduced by 9%, and the acceleration was reduced by 57%.
- 5- In the experiment, the peak displacement at story five was reduced by 16%, and the acceleration at story five reduction 37%.
- 6- In theory, the peak displacement at story five was reduced by 14%, and the acceleration reduction by 14%.

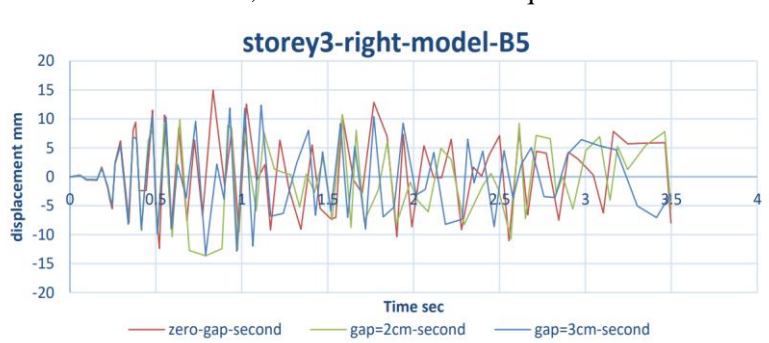
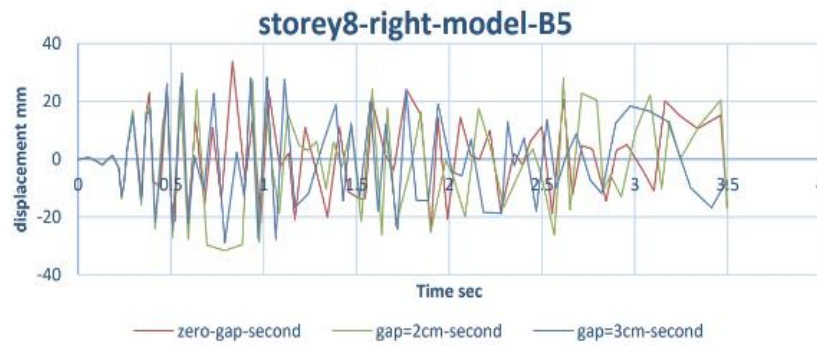
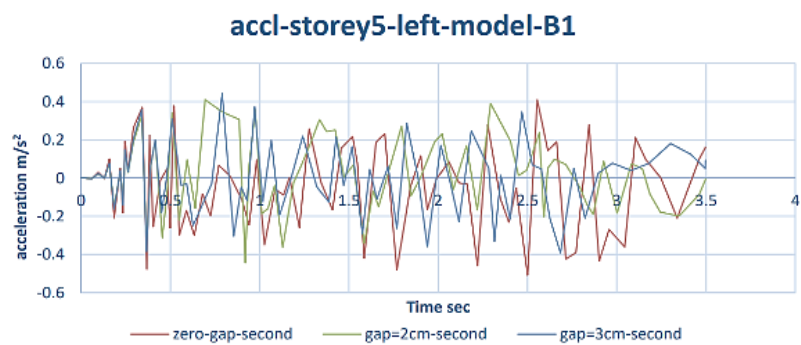
a) Displacement

b) Displacement

c) Displacement

d) Acceleration

e) Acceleration

Fig. 9 The acceleration at stories (three, five, and eight) under El-Centro earthquake.
